January 8, 2025

## Avoid The Strain!

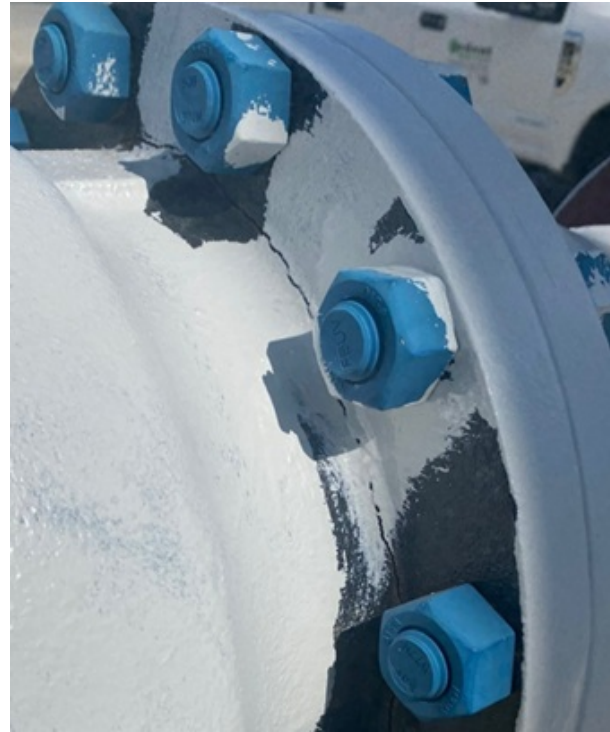
On occasion a customer will call, complaining that a gate valve flange has broken. For instance, a painting contractor discovered this crack while applying a protective coating to exposed piping and valves in a new Water Treatment Plant. The crack was in the casted portion of the valve body that transitions into the connecting flange.

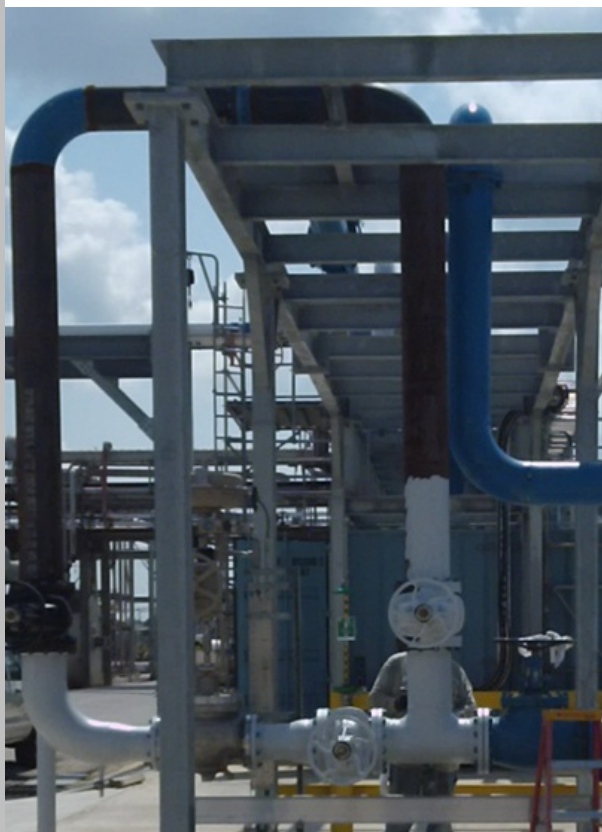
**Pipe Strain** is the likely explanation. A 10-inch Milwaukee Valve gate is being used as an isolation valve for some inlet bypass piping. In this system, the valve alone weighs 436 pounds. The rest of the system includes two other 400+ lb. gate valves, two long (more than 15') runs of iron pipe, the related elbows, and the columns of water contained in the piping. All of this totals a heck of a load for our cast-iron problem, with little or no visible support to this system. Pipe strain and flange breakage? Obviously!

Pipe strain is a leading cause of premature system failure and should be the number one item to correct in your system. Doing so will allow you to get ahead of unplanned failures, downtime, and callbacks.
